Investigation of traffic induced vibrations and luminaire behavior

Yoon-Si Lee

Department of Civil Engineering and Construction, Bradley University, Peoria, IL., USA

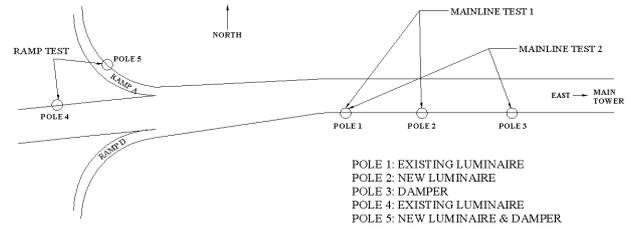
Fig. 1: Condition and location of poles

The plan permitted the comparison of an existing pole and LPS luminaire with three retrofitted poles: a pole with a new HPS luminaire (POLE 2), a pole with both a new HPS luminaire and a damper (POLE 5), and a pole with an existing LPS luminaire and damper (POLE 3).

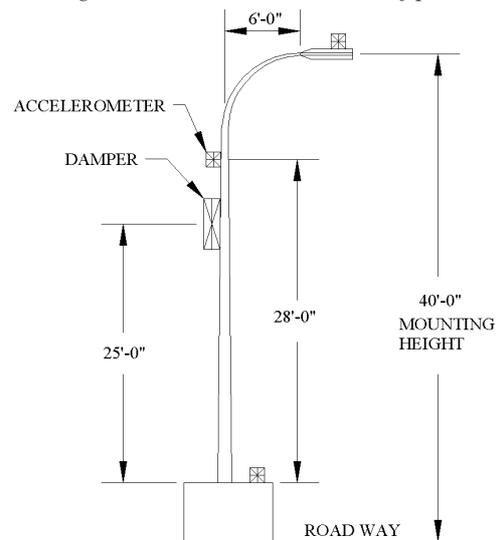
Fig. 2: Location of accelerometer and damper

From the three dampers available from the pole manufacturer, an external vibration damper was selected. The damper is a capped, 2-3/8-inch diameter tube 12 inches long containing a loose 1-1/2-inch diameter steel rod with plastic end caps. A slotted aluminum extrusion bracket provides for a strap or hose clamp attachment to the side of the light pole.

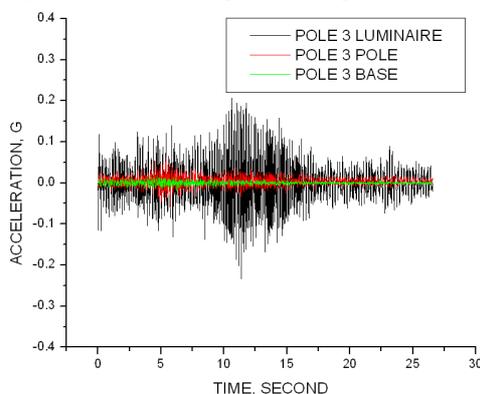
(a) Mainline Test 2, Pole 3

- The luminaire, pole, and base measurements for peak acceleration for the LPS pole without a damper and the LPS pole with a damper were nearly the same. This suggests that the damper was ineffective in reducing accelerations for the existing LPS luminaire and pole installation.

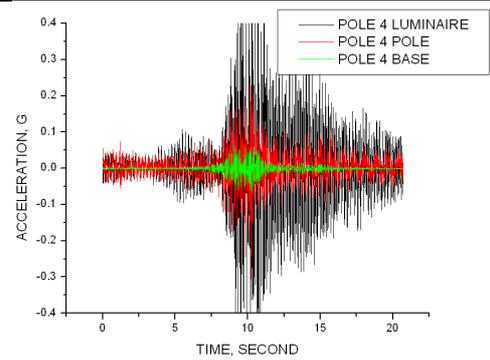
(b) Ramp Test, Pole 4

- Peak accelerations on poles on the ramp and approach span were consistently higher than on the cable-stayed span (± 0.14 to 0.31 g vs. ± 0.06 to 0.09 g). This suggests that the poles on the ramp and approach span are responding to the higher traffic vibrations.

- The LPS luminaries on the cable-stayed bridge had lower peak accelerations than the LPS luminaire on the approach span (± 0.21 to 0.40 g vs. $+0.68/-0.48$ g). This suggests that the LPS luminaries on the approach span and ramps are responding to the higher traffic vibrations on the ramp and approach span than on the cable-stayed span.

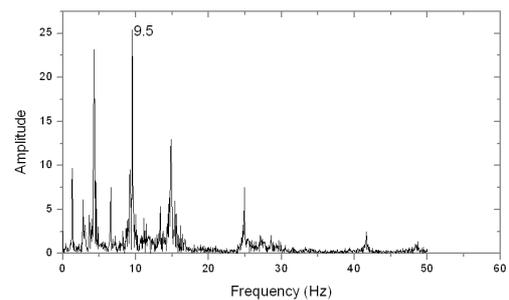
(a) Mainline Test 1, Pole 1 Luminaire

- Peak accelerations and dominant frequencies on the LPS luminaries and bulbs were essentially identical. This suggests that the bulbs were not moving independently of the luminaries under the traffic vibrations on the cable-stayed span.

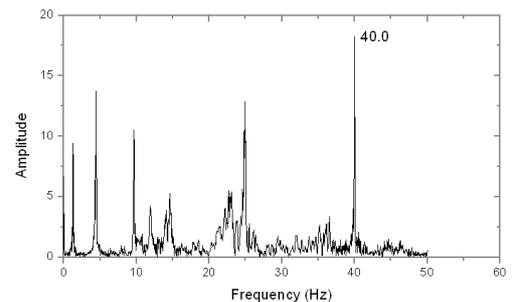
(b) Ramp Test, Pole 4

measured on the Burlington Bridge ranged from low to high, but most were at lower modes. Van Dusen [9,10&11] stated that wind generally excites a pole at a resonant frequency but that traffic excites poles at non-resonant frequencies. It appears that the frequency measurements indicate that traffic rather than wind was the driving force for the measured vibrations.
